Reserve Study Project No. 10014.2

Prepared for Miller Ranch Condominium Association Edwards, Colorado

> Prepared by Bornengineering 8310 South Valley Highway, 3<sup>rd</sup> Floor Englewood, Colorado 80112

> > December 9, 2010

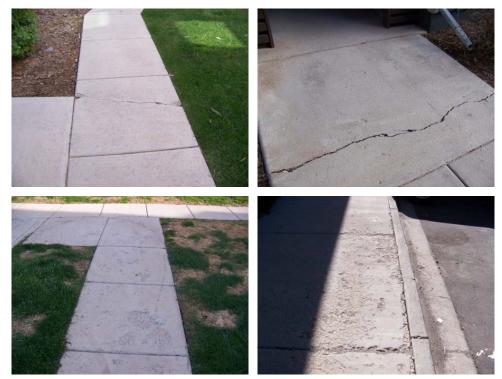
**Condition:** Fair condition with extensive cracking and/or deterioration noted. Some of the cracked areas have settled or heaved resulting in differential edges, which can be a tripping hazard if not corrected.

- Cyclically remove and replace damaged sections of the concrete walkways every 3 years, starting in 2011.
- Inspect the surface and repair any cracks or deteriorating concrete walkways every year. This cost is not included in the Study because normally associations perform this as a maintenance item and the cost is considered an operating expense.

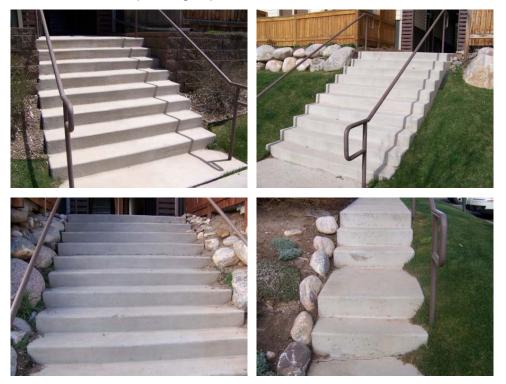
#### B2. Concrete Stairs

**Condition:** Good to fair condition with visual signs of deterioration and/or cracking noted.

- Cyclically remove and replace damaged sections of the concrete stairs every 6 years, starting in 2015.
- Inspect the surface and repair any cracks or deteriorating concrete stairs every year. This cost is not included in the Study because normally associations perform this as a maintenance item and the cost is considered an operating expense.

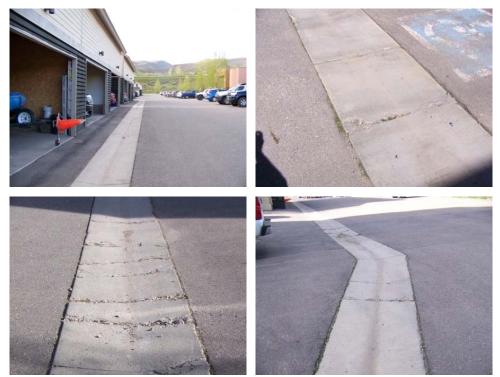
# B3. Concrete Drain Pan

**Condition:** Good to fair condition with minor cracking and moderate deterioration noted.

- Cyclically remove and replace of the damaged sections of the concrete pan every 6 years, starting in 2011.
- Inspect the surface and repair any cracks or deteriorating concrete pan every year. This cost is not included in the Study because normally associations perform this as a maintenance item and the cost is considered an operating expense.

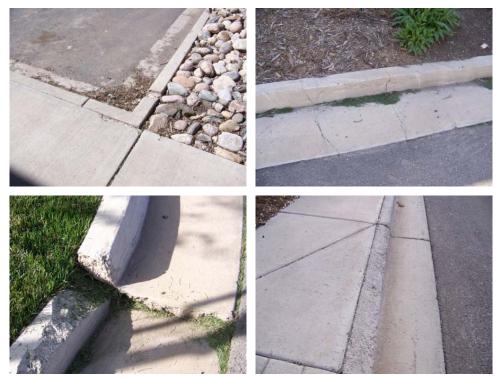
## B4. Curb and Gutter

**Condition:** Good to fair condition with areas of significant cracking, deterioration, and damaged sections noted. Generally, most of the damage to the curb and gutters within the Miller Ranch community are mainly from the heavy use of snow-traction aggregate and chemicals along with snow plowing operations.

- Cyclically remove and replace of the damaged sections of the concrete curb and gutter every 6 years, starting in 2011.
- Inspect the surface and repair any cracks or deteriorating concrete curb and gutter every year. This cost is not included in the Study because normally associations perform this as a maintenance item and the cost is considered an operating expense.

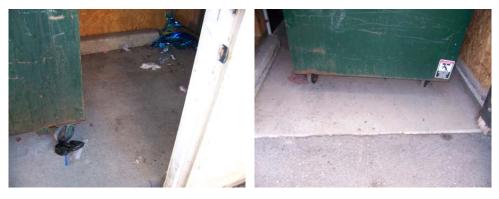
#### B5. Concrete Dumpster Slab

**Condition:** Good to fair condition with significant cracking and/or deterioration noted in areas.

- Cyclically remove and replace of the damaged concrete dumpster slabs every 6 years, starting in 2011.
- Inspect the surface and repair any cracks or deteriorating concrete dumpster/garage slabs every year. This cost is not included in the Study because normally associations perform this as a maintenance item and the cost is considered an operating expense.

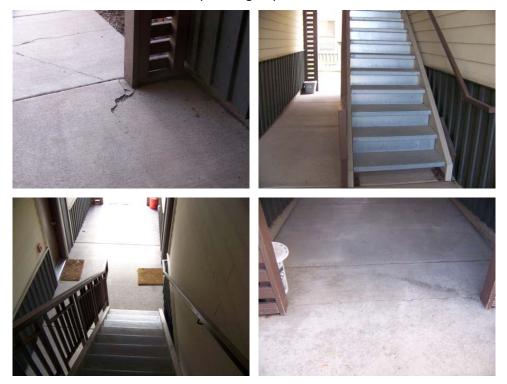
#### B6. Concrete Breezeways

**Condition:** Overall in good condition with minor cracking and/or deterioration noted in areas.

- Cyclically remove and replace of the damaged sections of the concrete breezeways every 6 years, starting in 2017.
- Inspect the surface and repair any cracks or deteriorating concrete breezeways every year. This cost is not included in the Study because normally associations perform this as a maintenance item and the cost is considered an operating expense.

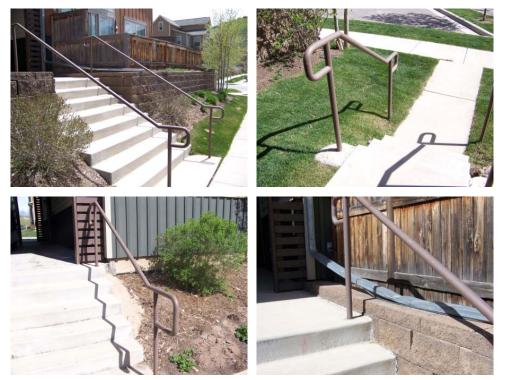
#### C1. Metal Railings

**Condition:** Good condition with no visual signs of failure.

- Cyclically scrape, rust proof and paint the metal railings every 6 years, starting in 2011. The costs associated with this action are not funded in the Study, as we were informed it is part of the operating budget.
- Remove and replace the metal railings in 2029.

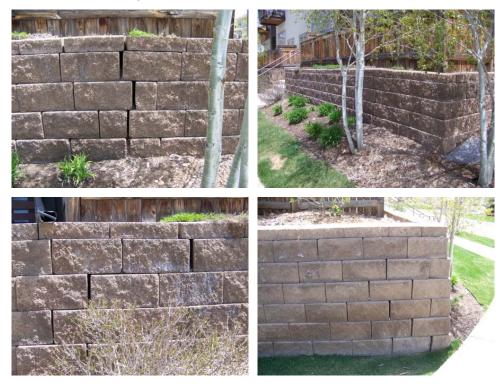
## C2. Block Retaining Walls

**Condition:** Fair condition. The block retaining wall along the west side of Building A is noted to be failing due to the large separation/gaps between blocks and bowing of the blocks. The most common reasons for failing retaining walls are incorrect installation and poor subgrade preparation. It should be noted that retaining walls higher than 4 feet are typically required to be designed and approved by a licensed engineer.

• Have a professional Structural Engineer evaluate, analyze, and determine the course of action to repair the structural integrity of the block retaining walls in 2011, or sooner. Engineering fees are included in this action component. Major repair of the block retaining wall associated with the west of Building A will most likely be needed. The cost associated with repair has been included in this action component.

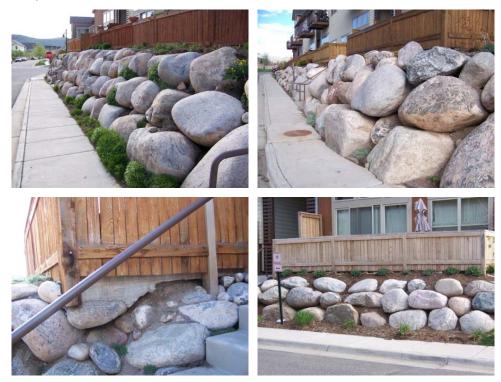
## C3. Boulder Retaining Walls

**Condition:** Presumed to be in good condition. We noted several areas where large boulders are stacked on top of small boulders and this can cause instability over time. We also noted that subgrade material is visually evident between gaps of the boulder which leads to the assumption that the boulder retaining walls do not incorporate landscape fabric to mitigate the amount of fines penetrating through the face of the wall and the assist in the erosion of the backfill. We were informed by the Association that the concrete patios of the condos are floating slabs and without adequate stabilization of the soils behind the retaining walls, it can cause the slabs to move and thus, cause movement in the patio fencing.

Have a professional Structural Engineer evaluate the structural integrity of the boulder retaining
walls and the soil stability behind the boulder retaining walls in 2011. The Structural Engineer
should determine the course of action to repair (if needed) the structural integrity of the block
retaining walls and/or soils behind the retaining walls. Engineering fees are included in this
action component.

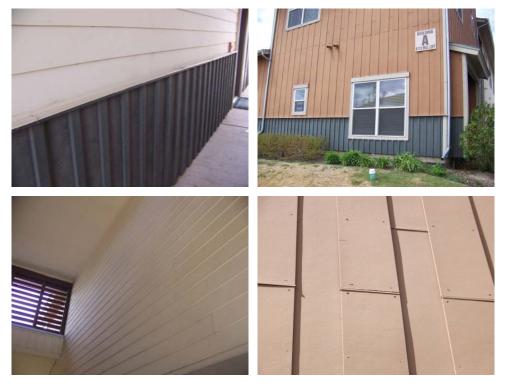
D1. Siding and Trim

**Condition:** Good to fair condition. We noted several areas where the paint has deteriorated due to snow accumulation during the winter season.

Cyclically prep and paint the siding and trim and replace any damaged or deteriorated sections for condo buildings every 7 years by Phase with Phase 1 (Buildings A, B, C, and D) starting in 2014, Phase 2 (Buildings E, F, and G) starting in 2015 and Phase 3 (Buildings H, I and J) starting in 2016.

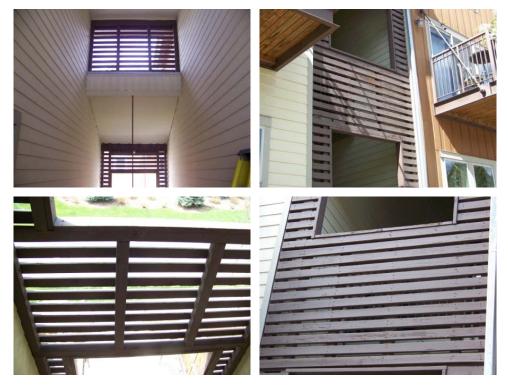
#### D2. Wood Building Features

**Condition:** Fair condition. We noted that the paint associated with a majority of the wood features is pealing and/or fading.

- Cyclically prep and paint the wood features and replace any damaged or deteriorated boards for condo buildings every 7 years by Phase with Phase 1 (Buildings A, B, C, and D) starting in 2011, Phase 2 (Buildings E, F, and G) starting in 2012 and Phase 3 (Buildings H, I and J) starting in 2013.
- Inspect and replace the 2" x 4" boards for rotting, deterioration, and cracking every year. This cost is not included in the Study because normally associations perform this as a maintenance item and the cost is considered an operating expense.

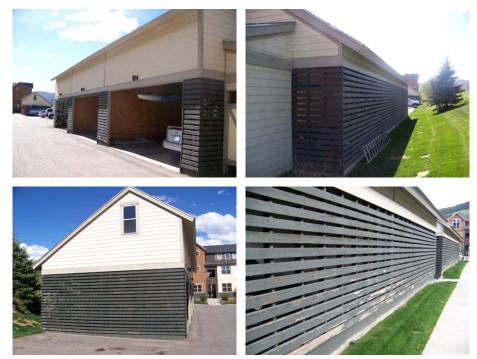
#### D3. Garages

**Condition:** The lap siding and hard board products are in good condition while the wood features and trash enclosure hinged doors are in fair condition. We noted that the paint associated with garages is in fair to poor condition due to significant areas of pealing and/or fading.

- Cyclically prep and paint the garages and replace any damaged or deteriorated sections every 7 years, starting in 2011.
- Cyclically remove and replace damaged sections of the concrete garage slabs every 6 years, starting in 2017.
- Cyclically remove and replace the asphalt shingled roofs for garages every 20 years, starting in 2025.
- Inspect and replace the 2" x 4" boards for rotting, deterioration, and cracking every year. This cost is not included in the Study because normally associations perform this as a maintenance item and the cost is considered an operating expense.

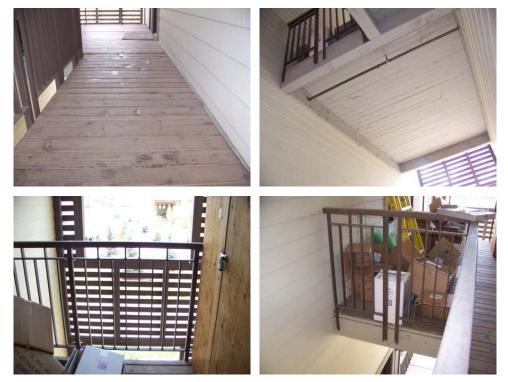
# D4. Entry Decking

**Condition:** Good to fair condition. We noted that there are a few cracked and/or loose floor boards. We also noted a few cracked joists that should be continually monitored.

- Cyclically apply a new top coat of waterproof sealant and replace damaged and/or deteriorated wood boards every 5 years, starting in 2015.
- Cyclically scrape, rust proof, and paint the guard railing every 5 years, starting in 2015.
- Inspect and replace damaged and/or deteriorated wood boards every year along with inspecting, maintaining, and repairing the guard rail protection. The cost is not included in the Study because normally associations perform this as a maintenance item and the cost is considered an operating expense.

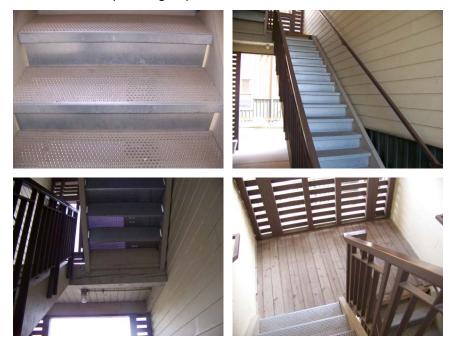
#### D5. Stairs and Landing

**Condition:** Good condition with visual signs of cracking on wood floor boards associated with the landings and stress cracks on the framing joists.

- Cyclically apply a new top coat of waterproof sealant and replace damaged and/or deteriorated wood boards every 5 years, starting in 2015.
- Cyclically scrape, rust proof, and paint the guard railing and handrails every 5 years, starting in 2015.
- Remove and replace handrails in 2040.
- Inspect and replace damaged and/or deteriorated wood boards every year along with inspecting, maintaining, and repairing the guard railing, handrails, and metal treads. The cost is not included in the Study because normally associations perform this as a maintenance item and the cost is considered an operating expense.

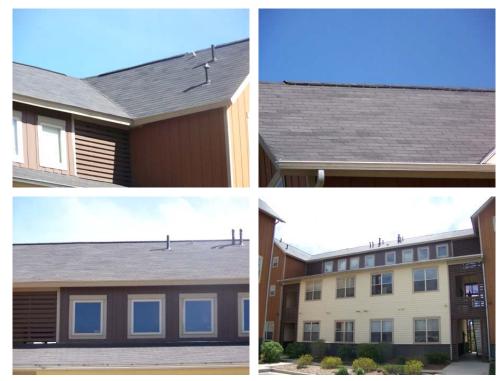
# E1. Asphalt Shingled Roofs

**Condition:** The roofs appeared to be in good condition, based only on the visual characteristics of the shingle material.

• Cyclically remove and replace the asphalt shingled roofs for the condo buildings every 15 years by Phase with Phase 1 (Buildings A, B, C, and D) starting in 2020, Phase 2 (Buildings E, F, and G) starting in 2026 and Phase 3 (Buildings H, I and J) starting in 2027.

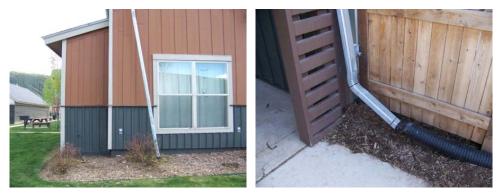
# E2. Gutters, Downspouts and Extensions

**Condition:** Good to fair condition overall. We noted some areas where the layout of the downspout extensions is unsatisfactory for effectively conveying the stormwater discharge from the downspouts. We also noted a significant amount of downspouts that are no longer supported to the condo buildings which seemingly allows the downspouts to move freely, especially during windy conditions. It should be noted that there are a few downspouts that are not connected and/or connected incorrectly to the downspouts extensions and/or non-perforated pipe. We recommend additional non-perforated and/or perforated piping be installed in order to effectively convey stormwater discharge at least 5 feet away from the foundations of the condo buildings and retaining walls. We also recommend that gutters and downspouts be installed on the garages to help reduce asphalt and landscape erosion from stormwater runoff from the roofs. However, we were informed the garages are a limited common element and the gutters, downspouts and extensions are not the responsibility of the Association.

- Cyclically remove and replace the gutters, downspouts and extensions for the condo buildings every 15 years by Phase with Phase 1 (Buildings A, B, C, and D) starting in 2020, Phase 2 (Buildings E, F, and G) starting in 2021 and Phase 3 (Buildings H, I and J) starting in 2022.

- Inspect and maintain gutters, downspouts, and extensions every year. This includes, but not limited to, connections, attachments, stormwater conveying, and downspout securing. The cost is not included in the Study because normally associations perform this as a maintenance item and the cost is considered an operating expense.
